# ISMP Medication Safety Alert!®

## Start the year off right by preventing these *Top 10 Medication Errors and Hazards* from 2020

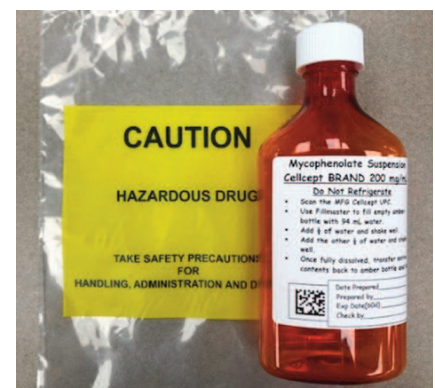
In one case, staff did not shake the manufacturer’s bottle well after reconstitution, as evidenced by granular powder found at the bottom of the bottle when the final few doses were drawn into ENFit-compatible syringes. In a second case, sludge appeared at the bottom of the bottle, indicating that the bottle was *perhaps* reconstituted correctly but then sat for a few days and settled. Once the pharmacy staff were ready to use that bottle, they did not shake

**Figure 1.** Amber bottle prepared by pharmacy with reconstitution instructions, which will later hold mycophenolate mofetil oral suspension.

it well enough before withdrawing doses. Failure to properly shake the suspension could result in an underdose from the first doses withdrawn from the bottle, or an

overdose from the last doses withdrawn from the bottle. Also, it appears that there may not be enough residual air inside the bottle to disperse it well once the suspension has settled.

The pharmacy where these events occurred standardized its mycophenolate reconstitution process to ensure the product is properly dispensed. The drug name, instructions for reconstitution, and the final concentration (200 mg/mL) are printed on a label and placed on an empty amber 240 mL bottle that will accommodate the volume of the reconstituted product (175 mL) (**Figure 1**, page 1). The 240 mL bottle allows more room for shaking the contents. The empty bottle is kept in a ziplock bag marked, “Caution: Hazardous Drug.” After reconstituting the powder in the manufacturer’s bottle per the instructions on the amber bottle label, the contents are then transferred to the amber bottle. This allows the suspension to be better visualized, and staff can inspect the bottom of the manufacturer’s bottle to make sure no powder clumps have formed. Finally, the amber bottle containing the reconstituted suspension is labeled with the date prepared, the expiration date, and the initials of the person preparing and checking the final product. A “shake well” label is also added. The bottle is then used to prepare unit doses in ENFit-compatible syringes. Mycophenolate meets the National Institute for Occupational Safety and Health (NIOSH) criteria as a hazardous drug and is known to cause teratogenic effects in humans. Therefore, appropriate personal protective equipment and engineering controls are needed when handling this product.
