ISMP Medication Safety Alert!®

Errors associated with oxytocin use: A multi-organization analysis by ISMP and ISMP Canada

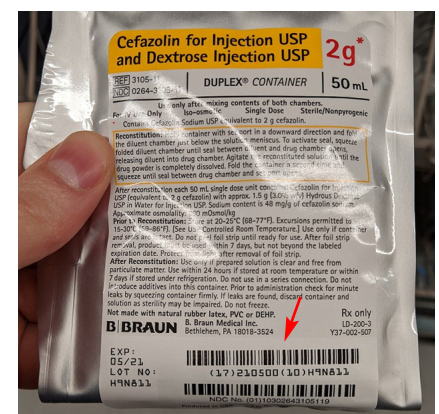
Problems with containers with dual linear barcodes. We received a report about nurses scanning the wrong barcode on B. Braun Duplex containers of ce**FAZ**olin injection (Figure 1). These and other B. continued on page 2 — **SAFETY briefs** >

Figure 1. Nurses are confusing the two linear barcodes on B. Braun Duplex containers.

Braun Medical intravenous (IV) products, including large volume parenteral IV bags, have two linear barcodes. For ceFAZolin Duplex containers, the uppermost linear barcode is for scanning the lot number and expiration date, although it isn’t clear if hospitals can take advantage of this barcode. (Please email ISMP at ismpinfo@ismp.org to tell us whether you routinely scan this barcode for lot number and/or expiration date so we have a sense of how often the barcode is used.) The barcode beneath this one is most essential, since it contains the national drug code (NDC) number for product identification, as required under the US Food and Drug Administration (FDA) Bar Code Rule.

When an unsuccessful scan occurs, it may happen because the nurse scans the wrong barcode or because the scanner hits and “reads” the uppermost barcode first, then sounds an alarm since this is not used for product identification. The person who reported the issue mentioned that scanning errors are a frequent occurrence at his hospital, which has led to nurse alert fatigue, time-consuming calls to the pharmacy, and delays in medication administration.

We have been in touch with B. Braun to suggest moving the barcode to another location, far away from the product identification barcode. Better yet, we suggested replacing the uppermost barcode with a 2D barcode. FDA allows a 2D barcode for this purpose (lot number and expiration date), if a linear barcode is still there for the NDC number as required by the FDA Bar Code Rule. Perhaps a 2D barcode could replace the uppermost linear barcode currently encoding the lot number and expiration date. If scanners can read a 2D barcode, they would be able to identify the drug as well as detect the lot number and expiration date in one scan. B. Braun agreed to look into the situation.

Meanwhile, if you are not using the lot number and expiration date linear barcode, it may be best to completely block out that barcode on the Duplex container label with a marker to direct nurses to the correct barcode to scan for product identification. Otherwise, it will take time to educate pharmacy and nursing staff about the proper way to scan these containers.

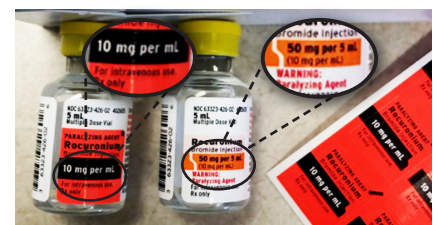
Rocuronium peel-off label shows amount per mL not per vial. When checking a rapid sequence intubation kit, a pharmacist noticed that the strength expressed on rocuronium 5 mL vials from Fresenius Kabi had changed from the usual 50 mg/5 mL to 10 mg/mL. Upon closer inspection, the pharmacist realized that the manufacturer had added a peel-off label noting 10 mg/mL over the actual vial label that states 50 mg/5 mL (**Figure 1**). During a busy intubation scenario, someone might mistake the vial as containing a total of 10 mg, not 50 mg.

Figure 1. Vial on left contains 50 mg/5 mL but the peel-off overlay states 10 mg per mL, which may be confused as the total amount in the vial. Vial on right has the peel-off label removed. Additional peel-off labels are included in vial cartons.

The peel-off label is meant to be removed from the vial label and attached to a syringe once the drug has been drawn up. The pharmacy is now removing the 10 mg/mL peel-off label before dispensing the vials.

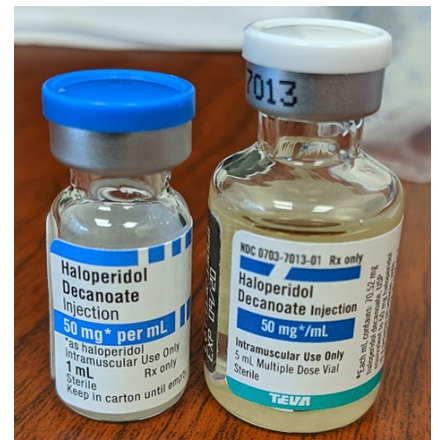
Unsafe product labeling. Teva's 5 mL haloperidol decanoate injection lists the drug strength, 50 mg/mL, on the outer carton as well as the immediate container label. However, the strength should be listed as 250 mg/5 mL (50 mg/mL), as required in USP <7>. The label indicates that the product is a 5 mL multiple-dose vial, but that information is easily missed since it is located apart from the 50 mg/mL expression in a smaller font (**Figure 1**). This almost led to a dispensing error at one hospital, when a pharmacy technician was about to refill an automated dispensing cabinet (ADC) pocket intended for a 50 mg vial of haloperidol decanoate with a 250 mg vial. In this case, the barcode was scanned, which identified that the vial contained the wrong amount of drug. For safety reasons, if a 250 mg vial is needed, purchase it from a different manufacturer until Teva's labeling is updated using the proper format for listing the concentration.

Figure 1. Teva's 1 mL vial on the left contains 50 mg of haloperidol, while the 5 mL vial on the right contains a total of 250 mg despite its error-prone expression of 50 mg/mL.
